Infrared Reflectance Imaging for Corrosion Inspection Through Organic Coatings (WP-0407)

13. SUPPLEMENTARY NOTES ASETSDefense 2009: Sustainable Surface Engineering for Aerospace and Defense Workshop, August 31 - September 3, 2009, Westminster, CO. Sponsored by SERDP/ESTCP.

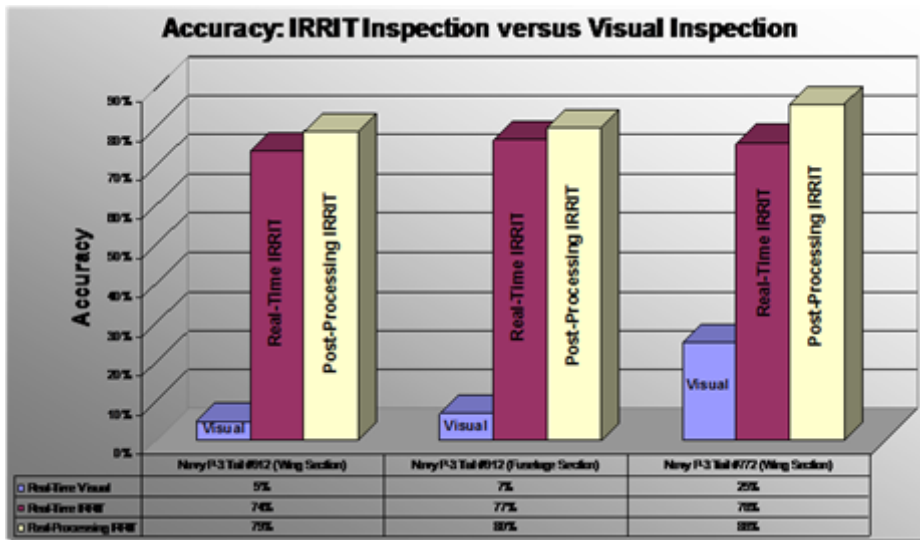
Results

1. The IR method directly images corrosion by-product through the paint system due to reflectance contrast differences of the substrate.
2. The visual method relies upon the identification of paint surface irregularities/blistering (i.e., paint degradation) as a result of substrate volume changes associated with corrosion formation.

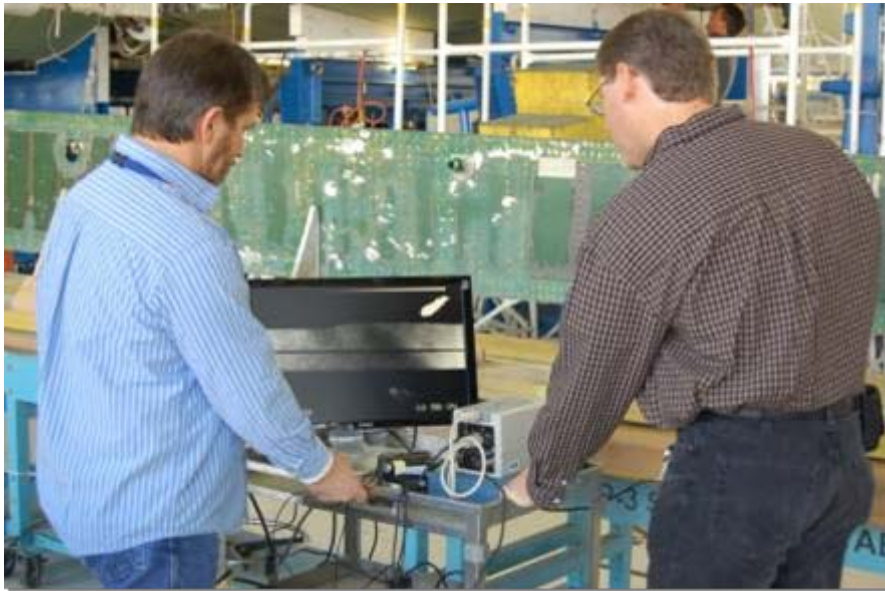
- Wing Spar Inspection – Engineering evaluation of incoming material condition following visual ID of Corrosion.

Mid-IR Inspection

Exfoliation Corrosion

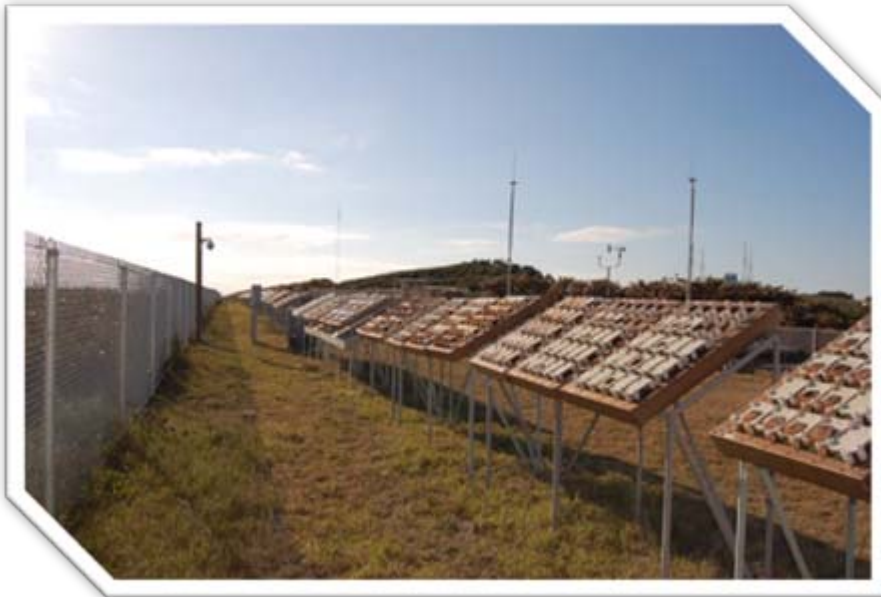
- Outdoor Exposure Testing – Evaluation of NAVAIR exposure coupons located at Cape Canaveral, FL

Exposure Test Facility

Exposure Coupons

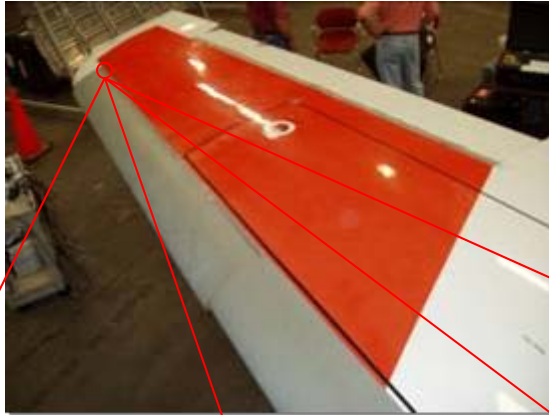
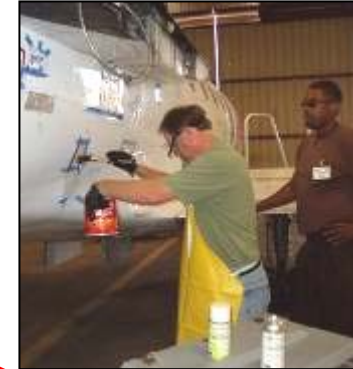
USCG HU-25 INSPECTION

Paint Thickness in
this Zone = ~6.5 mils

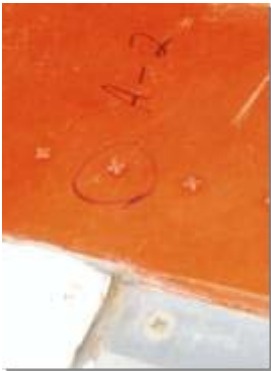
Visible Image - Painted

Note: Several corroded areas were found while checking the scan rate on this region, all corroded areas found via the IRRIT were confirmed by chemically stripping.
